Restoration of the Morell Bridge, Melbourne

Ian Godson - Managing Director, Remedial Engineering Group
 Albert van Grieken - Managing Director, Facade Technology

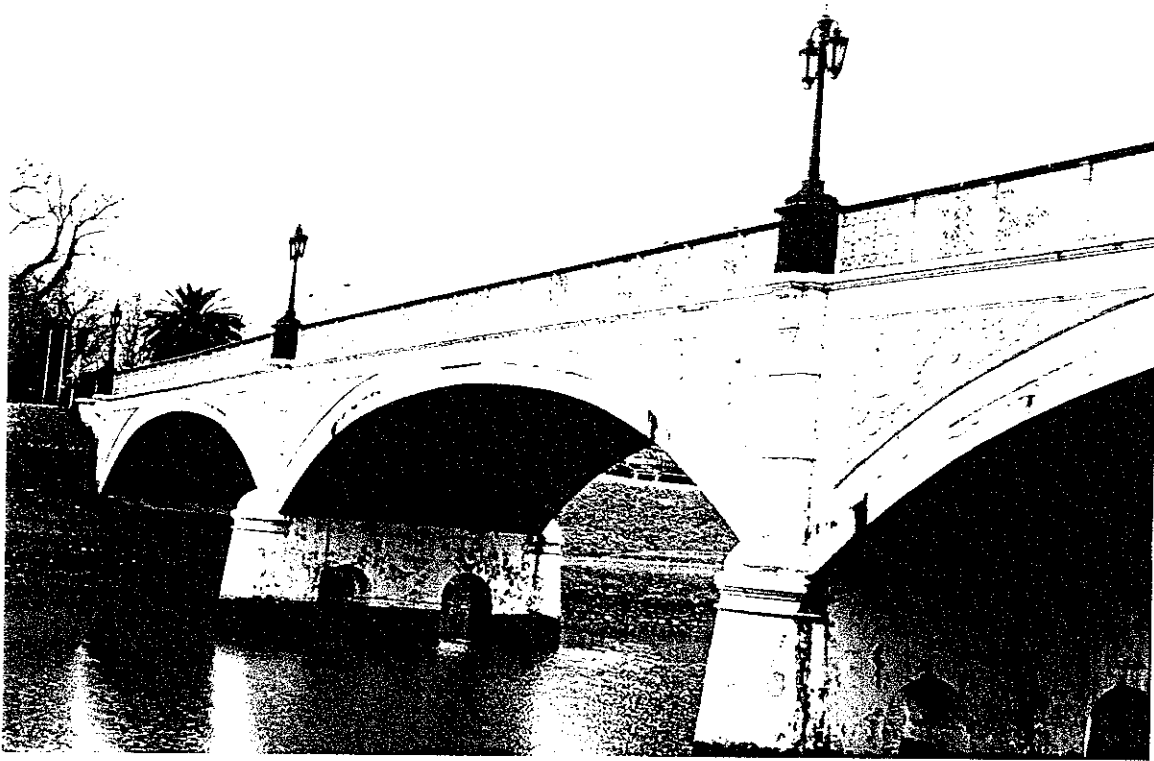
The most notable defects were concrete spalling at the soffit of the arches due to corroding reinforcement, and outward movement of the side walls. (Refer Photos 1, 2 and 3). The latter resulted in spalling render and heavy staining due to water seepage. Both defects appeared to have developed over a period of time as evidenced by previous repairs which were only partially successful.

Carefully located cores through the side walls confirmed the initial impression that these mass concrete walls were indeed moving outwards. It was considered that this was principally due to the dynamic traffic loading on the soil fill, the effects of which were translated laterally. Not surprisingly, it was also found that the bridge was holding water.

Photograph 1: Condition of Morell Bridge before restoration

- Install an effective drainage system to prevent the future build up of water inside the bridge.
- Arrest further outward movement of the side walls through the installation of stainless steel dowels.

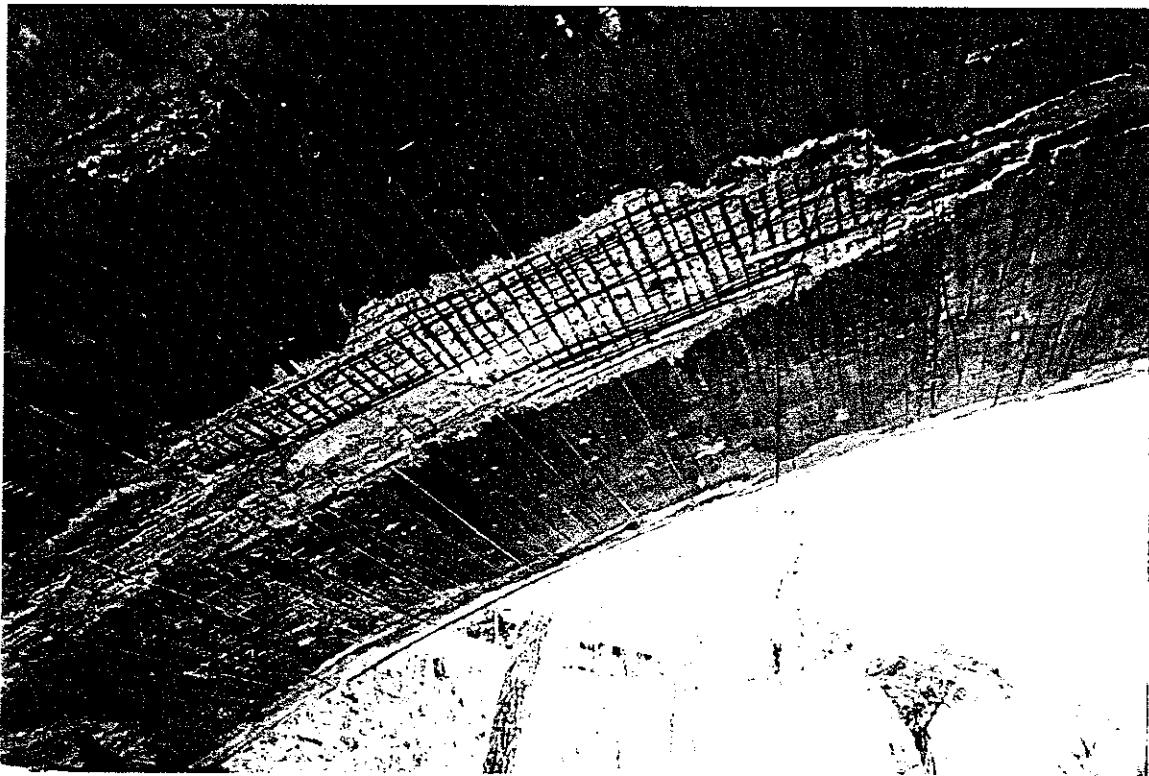
Surprisingly these revealed that the concrete strength which varied from 20 to 30 MPa lacked large aggregate. Partly as a result of this sandy mix, the soffit had carbonated to depths of up to 90mm, which is generally beyond the bottom layer of reinforcement. Elevated chloride levels were only local and attributed to contamination by the soil fill. The coincidence of spalling along edges and joints was therefore attributed to carbonation. The localised failure of the epoxy

patch repairs was a result of inadequate preparation and due to the creation of new anodic zones along their perimeters. Potential surveys carried out by Remedial Engineering indicated widespread corrosion activity.

Photograph 2: Concrete spalling at the soffit of the arches

With the use of Cathodic Protection to protect the reinforcement, a far reduced quantum of patch repairs were required. Only areas of spalled or delaminated concrete required exposure to, not behind, the reinforcement, with badly deteriorated reinforcement replaced.

All repairs used no reinforcement primers or bond coats and the repair concrete was a simple sand/cement of low resistivity, closely matching the characteristics of the original concrete.

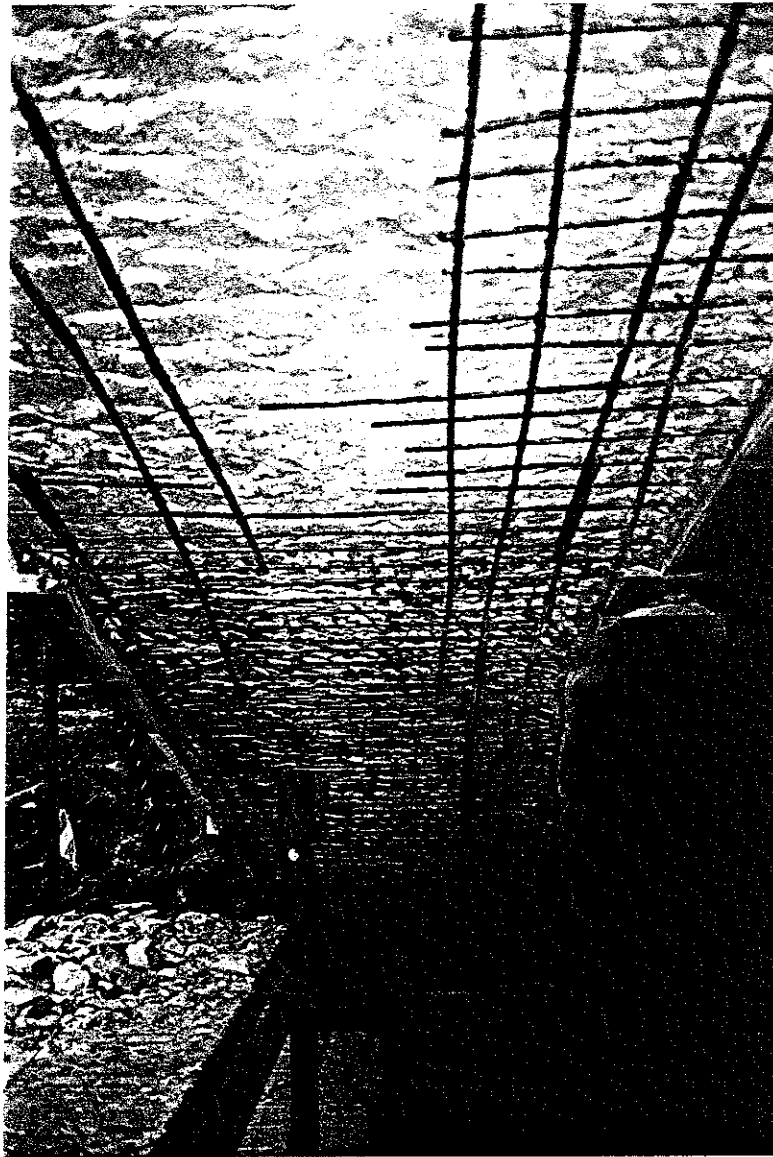
Photograph 3: Extent of concrete removal - North arch

The extensive delaminations along the outermost sections of the arches allowed easy access to the reinforcement, which was welded to ensure electrical continuity.

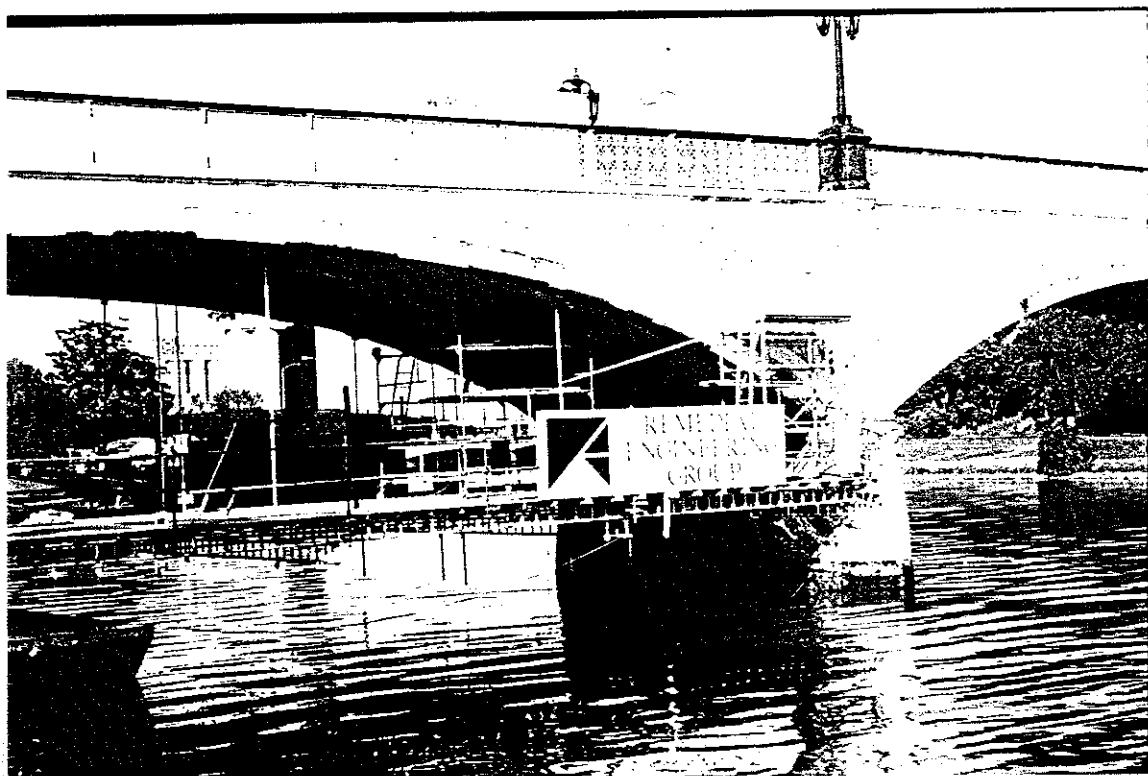
Photograph 4: Access platform suspended from the arches

Following competitive tendering Remedial Engineering was awarded the contract. Their access platform which was suspended from the arches required engineering to nominate loading patterns and sequences. (Refer to Photo 4).

All works were completed from a "hung" scaffolding system, with no disruption to vehicle, pedestrian or river traffic.

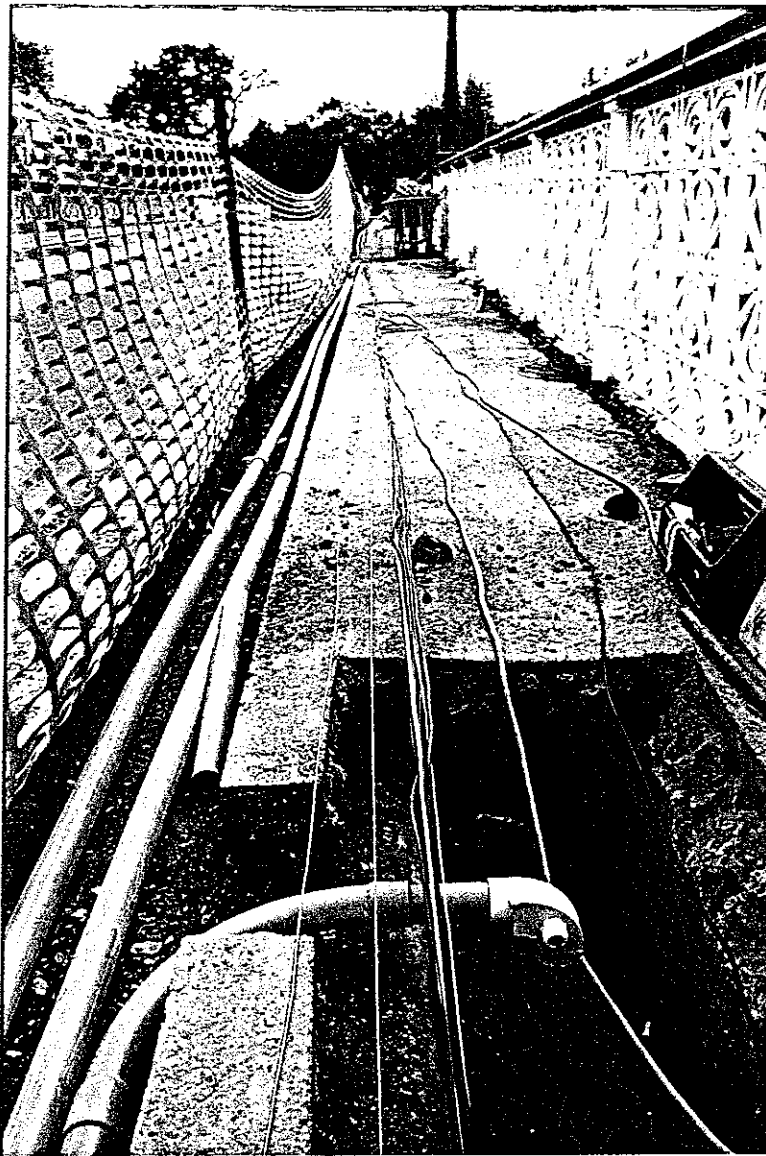
Photograph 5: Location of soil Anode

Four Silicon iron rod anodes embedded in a coke breeze backfill were installed in each span, giving a total of twelve. The anodes were inserted into the earth backfill section under the footpath, as shown in Photo 5. The anode cables were individually connected via a 0.01 Ohm shunt to enable measurement of the current supplied per anode.

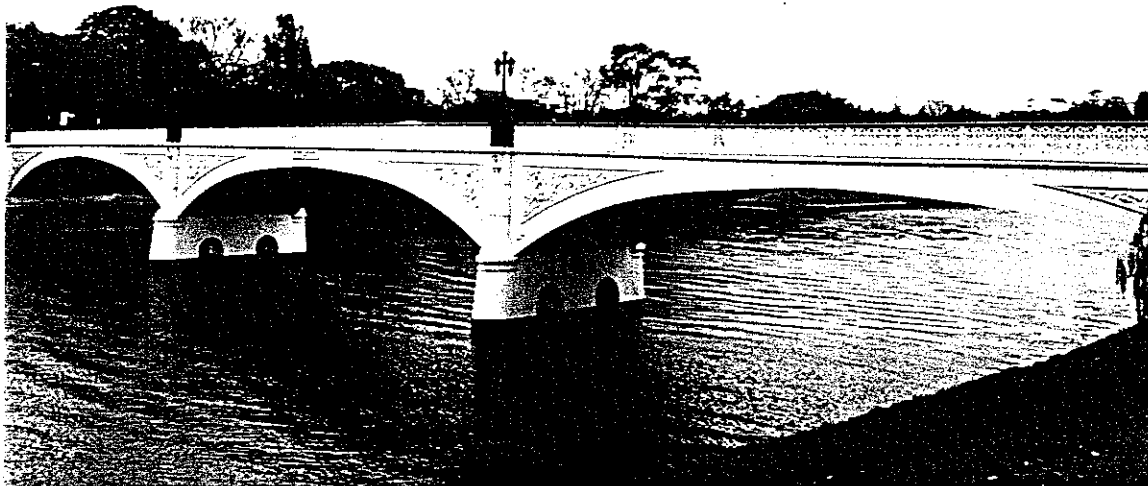
Photograph 6: Morell Bridge after restoration

The immediate impact of this repair and restoration project is visual. Gone are the stains, spalls and misalignments. Instead a remarkably attractive 'as new bridge'. (Refer to Photo 6).
